# RDKB KELLY CREEK DAM 2018 ANNUAL INSPECTION REPORT

Revision 0

On November 8, 2018, Austin Engineering Ltd. (Austin Engineering), performed the 2018 annual dam safety inspection for the Regional District of Kootenay Boundary's (RDKB) Kelly Creek Dam, located near Fruitvale, BC. Two representatives from the Village of Fruitvale also attended the site with Austin Engineering and provided access to the facility and answered questions related to operations and maintenance of the dam during the inspection.

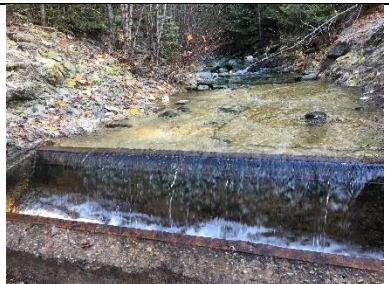
| <p><b>Photo #1:</b> Intake gravity drop without screens.</p> | <p><b>Photo #2:</b> Gap in the stairs at intake structure is consistent with last year.</p> | <p><b>Photo #3:</b> Intake overflow outlet.</p> |

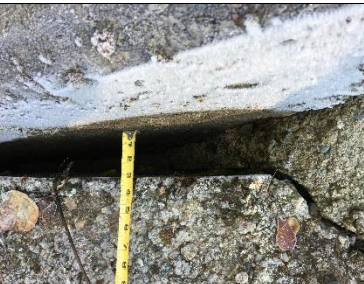
- Settlement around the intake structure was noted, measured, and photographically compared and appeared to be consistent with previous years.
- Vegetation on the steep south (left) side of the reservoir that was removed in a previous year appeared to be sufficiently maintained.

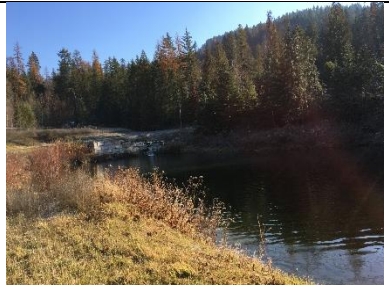
| <p><b>Photo #4:</b> Reservoir with conveyance pipe discharge.</p> | <p><b>Photo #5:</b> The lock block wall and conveyance pipe at the east end of the reservoir.</p> | <p><b>Photo #6:</b> Lock block wall behind conveyance pipe shows signs of movement. Possibly from pipe repair. Monitor for changes.</p> |

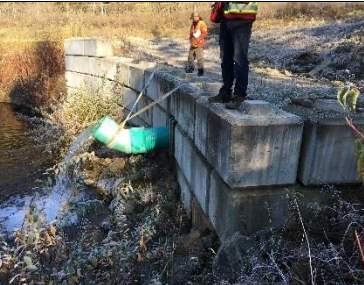
- Austin Engineering reviewed monthly checklists provided by the operator and noted that regular inspections are occurring on a monthly basis as required.
- The conveyance pipe behind the lock block retaining wall at the east end of the reservoir had a failure since the last inspection. The operator suspects this was due to equipment loading when clearing ice from the piping. At the time of inspection:
  - The conveyance piping had been replaced and was functioning.
  - The drainage swale behind the lock block had been reestablished and was effectively conveying seepage from the slope above around the south side of retaining wall structure.

4. Damage to the perimeter fencing at the east boundary should be repaired to maintain site security.
5. No equipment or vehicles should be parked on the pad above the lock block wall on the east side of the dam as the additional weight may put undue pressure on the saturated soil and piping which could lead to destabilization of the lock block wall. The wall should be monitored for signs of movement.

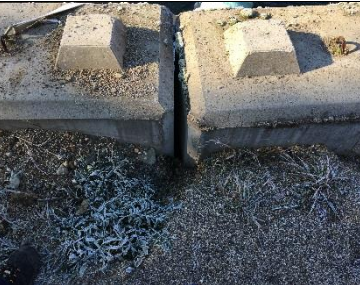
- There were signs of movement evident in the upper blocks on the lock block wall. This is suspected to be a result of reestablishing the conveyance piping after failure and is not necessarily a sign of slope instability. We do, however, recommend monitoring these blocks for movement.

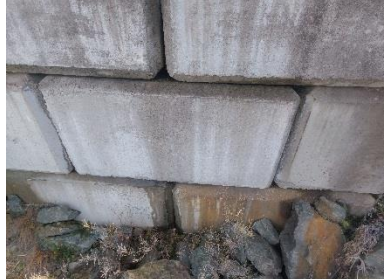
- Lower lock blocks in the retaining wall showed staining, suggesting that seepage was occurring; however these blocks were dry at the time of inspection.

| <p><b>Photo #7:</b> Lower lock block wall shows signs of seepage.</p> | <p><b>Photo #8:</b> Drainage swale behind lock block wall has been re-established.</p> | <p><b>Photo #9:</b> Fencing along east boundary damaged by snowplow.</p> |

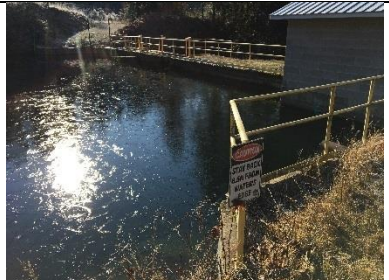
| <p><b>Photo #10:</b> Upstream view of spillway access walkway and reservoir.</p> | <p><b>Photo #11:</b> Trees on south (left) bank have been removed.</p> | <p><b>Photo #12:</b> Access road to south abutment lacking gate/fence opening.</p> |

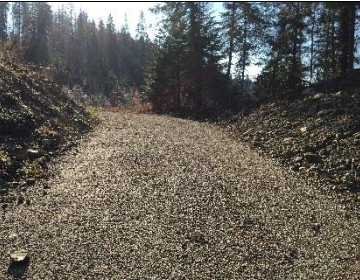
- The access road to the south abutment that was previously established from Old Mill Road is in good condition; however, the road is still fenced in and is not a functional equipment access point until a gate or opening is provided.

3. An equipment access gate should be added to the fencing to provide functional vehicle and equipment access between Old Mill Road and the south (left) abutment.

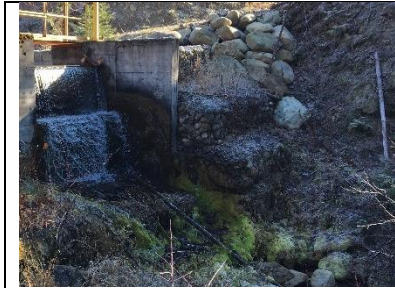
**Photo #13:** View of south abutment from downstream.

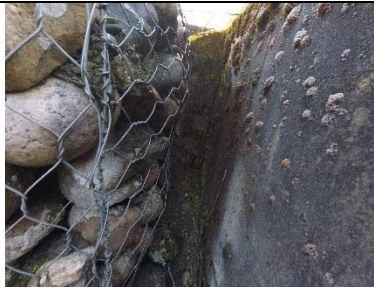
- Leakage noted in previous years at the south abutment was not visible at the time of inspection; however, review of monthly inspection reports indicates that this is still occurring throughout the year, and is likely a function of reservoir levels and seasonal conditions. The crack on the upstream south (left) wing wall suspected to contribute to this leakage was observed to be mostly submerged and still requires further investigation as noted in previous reports.

**Photo #14:** No seepage visible at south abutment during inspection.

1. Continue to monitor the left abutment directly behind the upstream concrete wall for seepage during monthly inspections. Special attention should be paid to this location in the spring when seepage is expected to be highest.

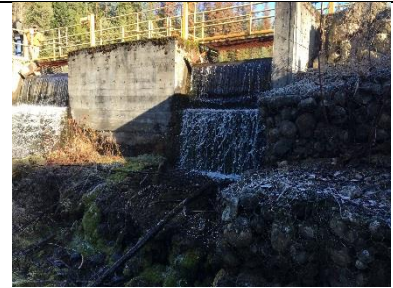
**Photo #15:** Gabion basket on south abutment show signs of settlement and movement away from concrete wall, but appear to be consistent with previous years.

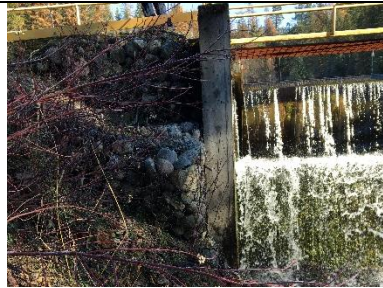
**Photo #16:** View of north abutment from downstream.

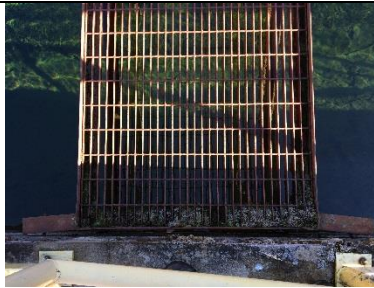
- Steel platform members and connections on the upstream side of dam face are showing signs of failure.
- The concrete of the exposed concrete face of the dam was observed to be in generally good condition where visible.

**Photo #17:** Steel platform connection members exhibit shear failure and connection failure.

10. Repair or replace the steel structure exhibiting signs of failure on the upstream side of the dam face.
11. Report any changes in the dam's condition to the Dam Safety Engineer when discovered in the field or noted on the monthly inspections.

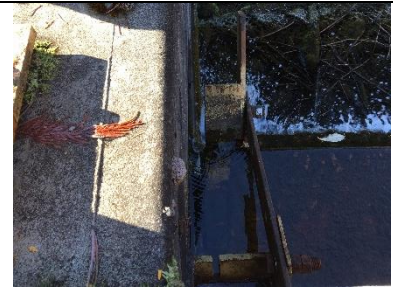
- The fencing at the east end of the property was damaged during snow removal from the previous year.
- A rubber side seal on the south side of the south (left) spillway gate was found to be damaged.

**Photo #18:** Rubber side seal damaged on south side of southern spillway gate.

7. Replace or repair the damaged rubber side seal on the south side of the south spillway gate to ensure a good seal is maintained on the spillway gate.

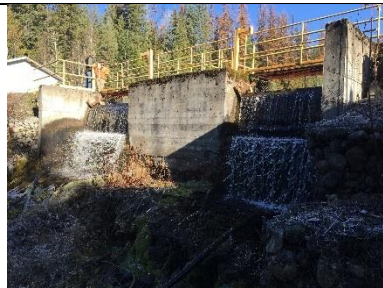
**Photo #19:** Spillway discharge flow observed from downstream.

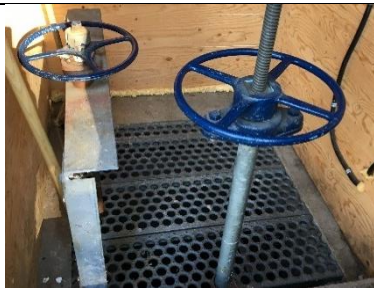
**Photo #20:** Intake valves and housing.

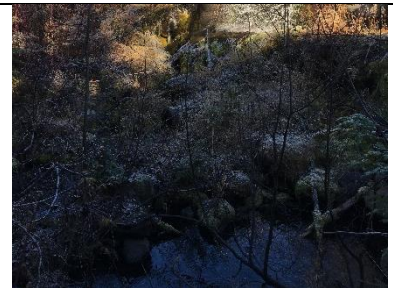
- The operator present at the time of inspection was not able to confirm whether the spillways or low-level outlets were exercised during the previous calendar year.

**Photo #21:** Low level outlet.

6. Ensure that the spillway gates and low-level outlet valves are exercised annually as recommended by the CDA Dam Safety Guidelines and required by the BC Dam Safety Regulations.

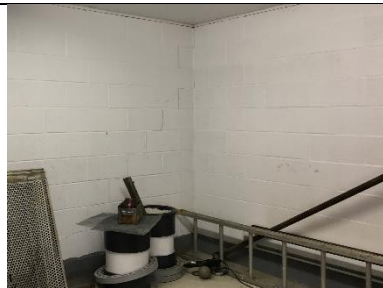
- The Water Treatment Plant intake structure located on the north side of the dam was noted to have cracking on the western wall. This crack appeared to be consistent with photos from previous years' inspections and suggests differential settlement of the structure has occurred in the past.

**Photo #22:** View of crack from interior wall.

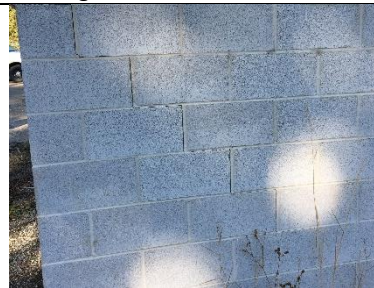
**Photo #23:** View of crack from exterior wall.
