**URBAN**  
systems

# Hydrologic Assessment of the Kelly Creek Watershed

March 2013  
1011.0041.01

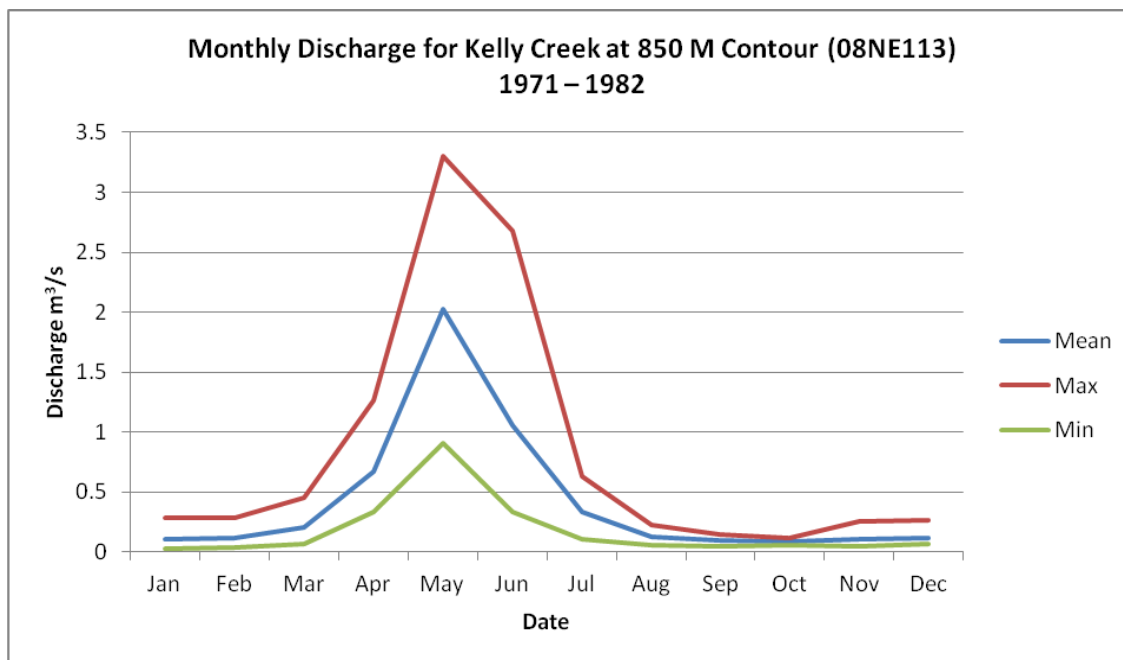
**Figure 2: Kelly Creek maximum, minimum and mean annual hydrographs**

For the purposes of this assessment the watershed has been divided into two parts, the upper 60% that is considered to be the snow sensitive zone and where the peak flows are generated and the lower 40% that is less sensitive to changes in forest cover that can impact peak flows and water yields. The  $H_{60}$  elevation is the 1,380m contour and is shown on Map1 as a heavy black contour line.

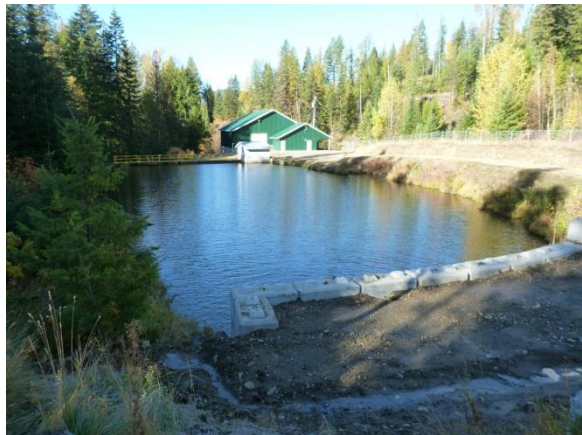
<b>1</b>	<b>Location</b>

BVWS Intake Pond	
	<b>GPS</b>	
	49° 6'25.09"N 117°30'49.46"W	
	<b>Notes</b>

Intake reservoir is in good condition.	
<b>2</b>	<b>Location</b>	
	Kelly Creek Intake structure, with gates and security fence	
	<b>GPS</b>	
	49° 6'25.99"N 117°30'45.41"W	
	<b>Notes</b>	
	Site security

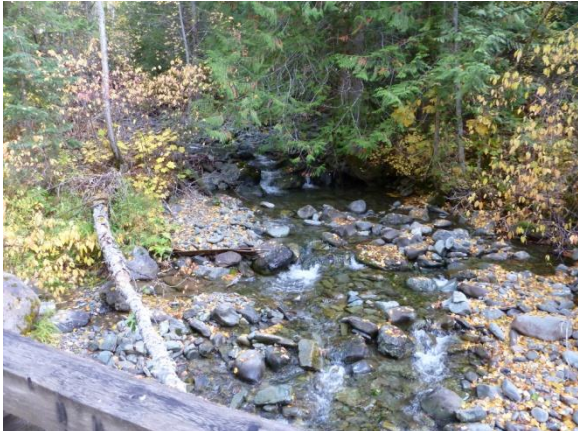
<table> <tr> <th>6</th><th>Location</th></tr> <tr> <td></td><td>Kelly Creek stream crossing</td></tr> <tr> <th>GPS</th><td></td></tr> <tr> <td></td><td>49° 6'47.79"N 117°29'32.10"W</td></tr> <tr> <th>Notes</th><td></td></tr> <tr> <td></td><td>Stable channel</td></tr> </table>	6	Location		Kelly Creek stream crossing	GPS			49° 6'47.79"N 117°29'32.10"W	Notes			Stable channel

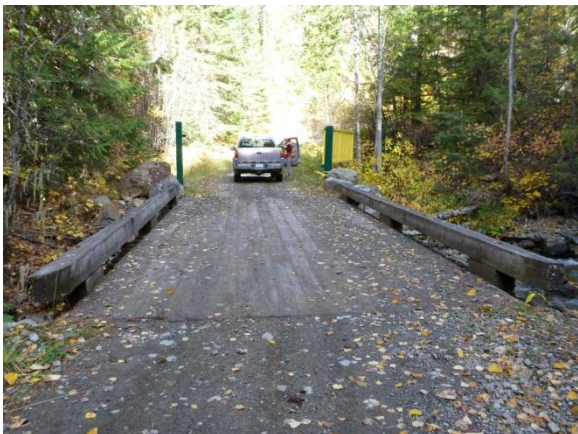
6	Location												
	Kelly Creek stream crossing												
GPS													
	49° 6'47.79"N 117°29'32.10"W												
Notes													
	Stable channel												
<table> <tr> <th>7</th><th>Location</th></tr> <tr> <td></td><td>Kelly Creek stream crossing</td></tr> <tr> <th>GPS</th><td></td></tr> <tr> <td></td><td>49° 6'47.79"N 117°29'32.10"W</td></tr> <tr> <th>Notes</th><td></td></tr> <tr> <td></td><td>Bridge in good condition</td></tr> </table>	7	Location		Kelly Creek stream crossing	GPS			49° 6'47.79"N 117°29'32.10"W	Notes			Bridge in good condition

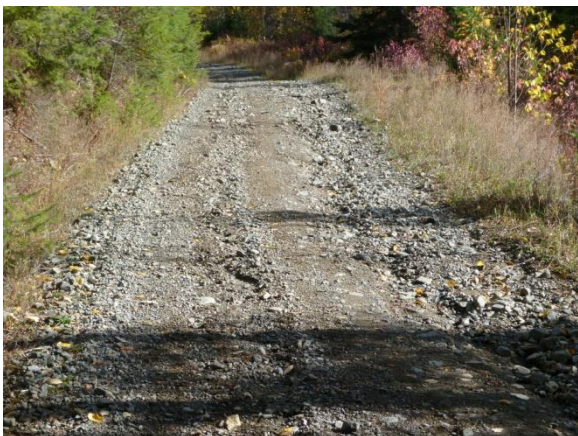
8	Location												
	Runoff and erosion present on steep road after the first stream crossing												
GPS													
	49° 6'58.26"N 117°29'17.07"W

There is some sediment delivery off the road running surface in the proximity of stream crossings throughout the watershed. The one section of road that is of concern is located between Locations 6 and 8 on the north side of the mainstem. There is ongoing accumulated runoff down a sustained grade eroding the running surface (Photo 8). The sediment is entering the mainstem at the bridge (Photo 7). Since this crossing is within 1.5km of the intake, the water quality at the intake is affected.

Notes													
	Sediment delivery from the road enters the creek at the bridge

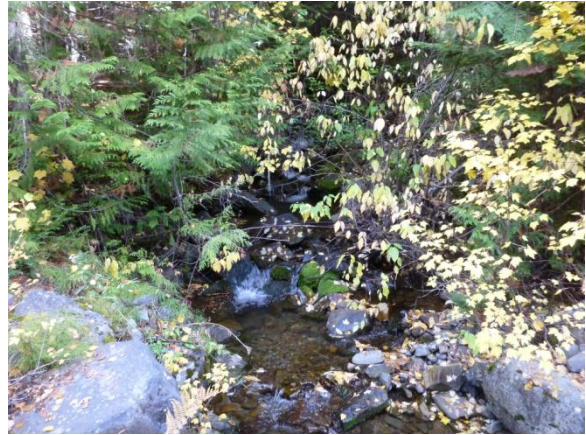
<b>9</b>	<b>Location</b>	
	Creek 1	
	<b>GPS</b>	
	49° 7'14.02"N 117°28'26.03"W	
	<b>Notes</b>	
	Stable channel

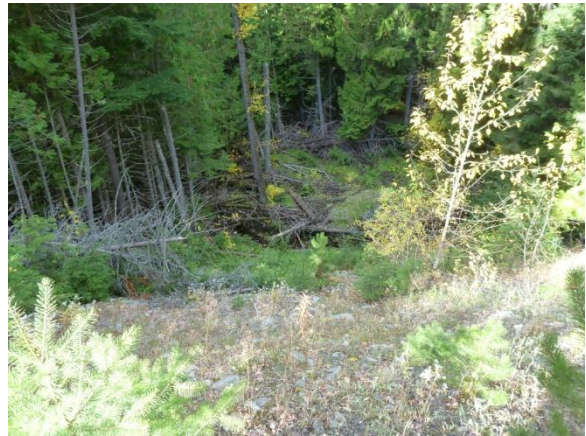
- Approximately 80m downstream of the crossing at Location 10 there had been a fillslope failure into the creek. The failure was not recent and the date is unknown. The debris from the slide, soil plus wood filled the creek channel but the water had cut a new channel through the debris (Photo 10). It did not appear that any remedial work had been done to remove the downed trees from the channel. The site was stable and there was no evidence of ongoing impacts to water quality.

Due to the rolling terrain with limited steep slopes mass wasting is not a major concern in the watershed. There were no natural landslides noted in the watershed. There is one fillslope failure of the main access road into a tributary that terminated in the stream (Figure 3 – Location 10). Although the debris filled the channel the flow has established a new channel through the debris and the site is generally stable (Photo 10).

<b>10</b>	<b>Location</b>	
	Landslide from cause by main FSR	
	<b>GPS</b>	
	49° 7'10.81"N 117°28'28.68"W	
	<b>Notes</b>	
	Wood debris and soil terminates in channel. Creek has cut a channel through the debris

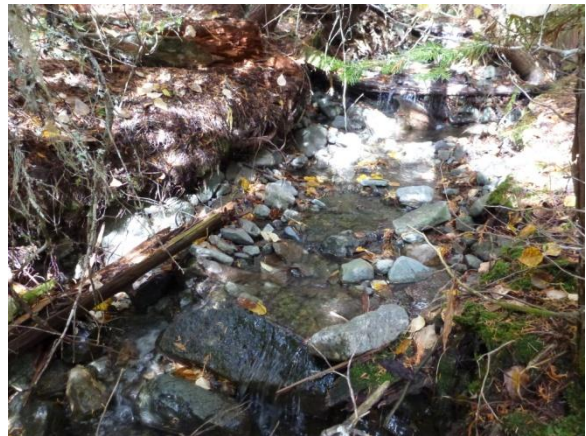
<b>11</b>	<b>Location</b>	
	Creek 2	
	<b>GPS</b>	
	49° 7'13.41"N 117°27'56.82"W	
	<b>Notes</b>	
	Stable channel

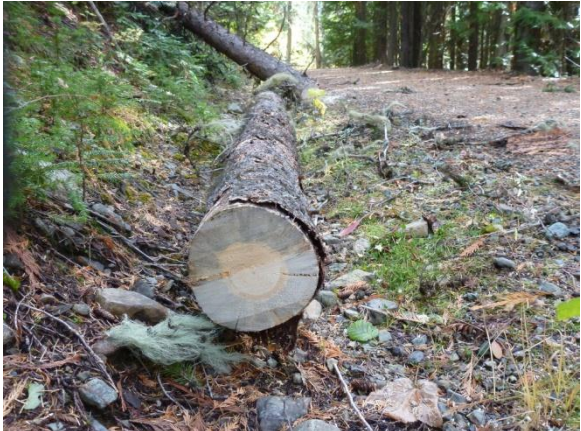
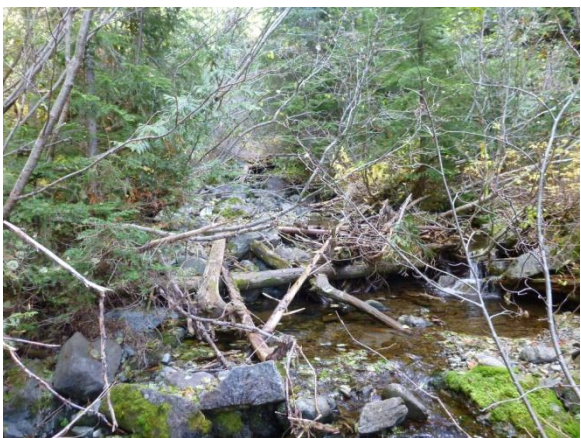
<b>13</b> <b>Location</b>

The biogeoclimatic zones in the watershed do not include significant stands of lodgepole pine. During the fieldwork it was noted that there is some lodgepole pine and some evidence of pine beetle damage but not extensive. There was little evidence of other forest health issues so the risks to the watershed are considered to be low.

Blue stain fungus in dead lodgepole pine	
<b>GPS</b>	
<b>Notes</b>

Blue stain fungus that kills mature lodgepole pine trees that are attacked by mountain pine beetle	
<b>14</b> <b>Location</b>	
Creek 3	
<b>GPS</b>	
49° 7'19.74"N 117°26'38.01"W	
<b>Notes</b>

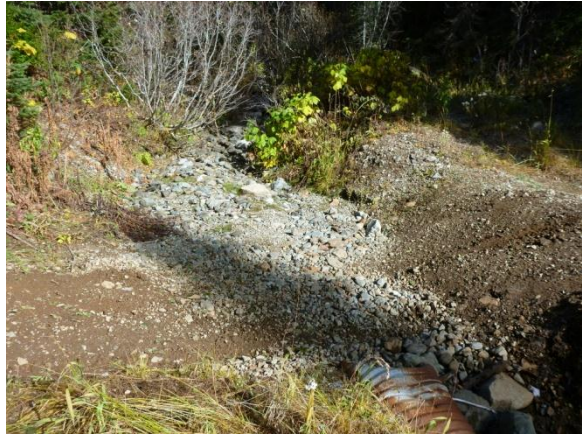
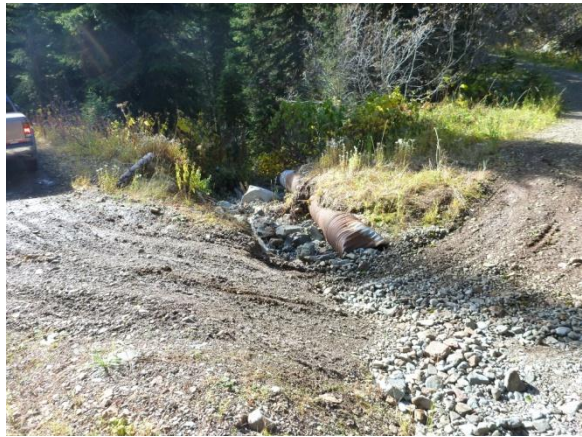
<b>16</b>	<b>Location</b>	
	Creek 4, road crossing	
	<b>GPS</b>	
	49° 8'21.63"N 117°26'27.71"W	
	<b>Notes</b>	
	Culvert blocked by debris causing flow to overtop and wash out the crossing

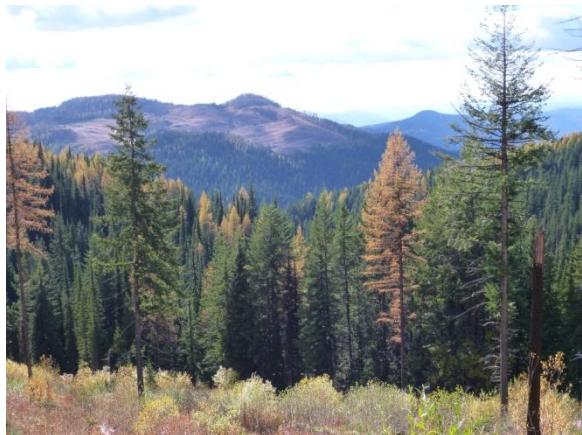
<b>17</b>	<b>Location</b>	
	View of south high elevation cut block and 2007 fire location	
	<b>GPS</b>	
	49° 7'36.59"N 117°26'15.71"W	
	<b>Notes</b>	
	Brown trees in foreground are larch as needles change in the fall.

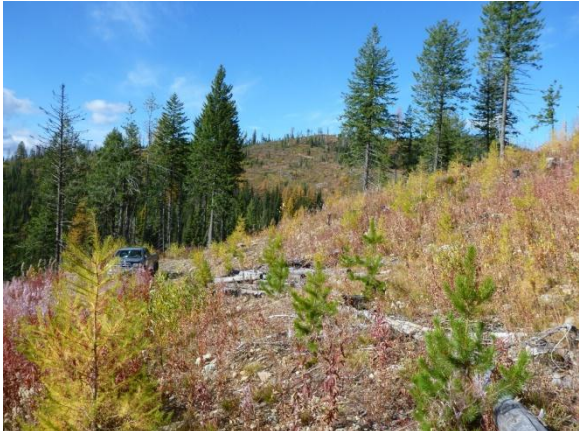
<div>18 Location</div> <div>View of mid-elevation cut block in the centre of the watershed</div> <div>GPS</div> <div>49° 7'36.59"N 117°26'15.71"W</div> <div>Notes</div> <div>Stable block and roads</div>

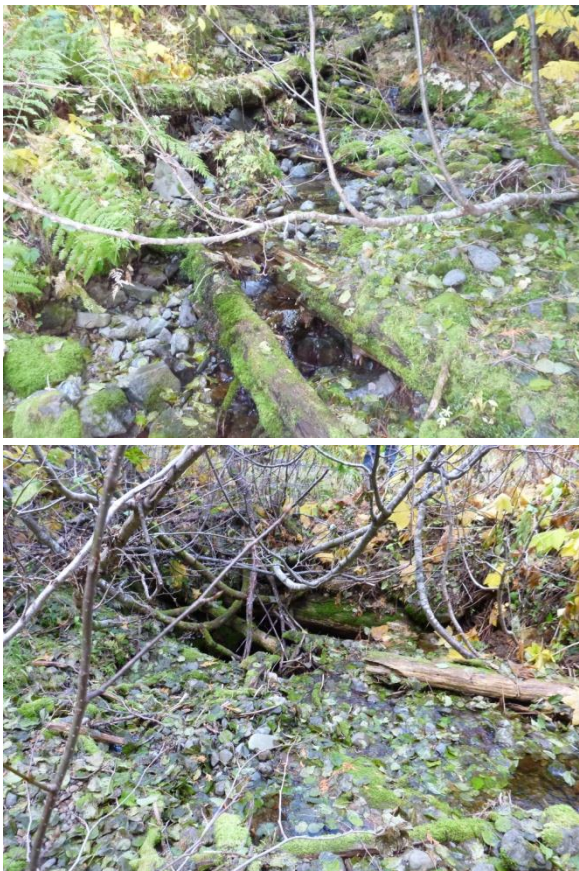
<div>19 Location</div> <div>Creek 5 – road culvert almost buried</div> <div>GPS</div> <div>49° 7'30.13"N 117°26'13.78"W</div> <div>Notes</div> <div>Stable channel. Second photo indicates debris blocking culvert</div>

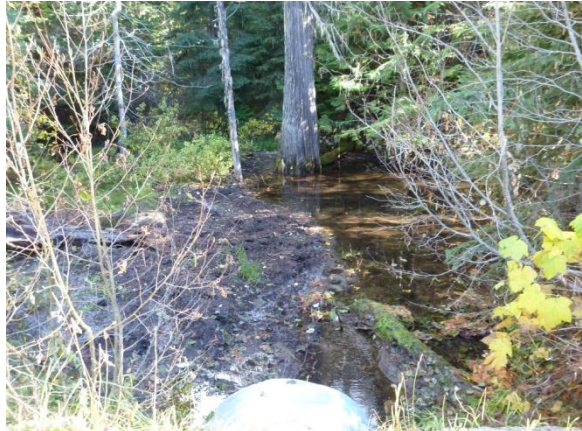
- At Location 21 it was noted that the placement of the culvert had created a pool upstream that was full of fine sediment and organics (Photo 21). The material did not appear to be recent and the flow through the pool was clear. There is a road system that crosses three tributaries upstream and there is one cutblock in the upper watershed but the source of the sediment appears to be natural.

<table> <tr> <th data-bbox="191 331 267 373">21</th><th data-bbox="267 331 810 373">Location</th></tr> <tr> <td data-bbox="191 373 267 457"></td><td data-bbox="267 373 810 457">Creek 6 – pooling on upstream side of road, perched culvert</td></tr> <tr> <th data-bbox="191 457 267 499">GPS</th><th data-bbox="267 457 810 499"></th></tr> <tr> <td data-bbox="191 499 267 552"></td><td data-bbox="267 499 810 552">49° 6'47.20"N 117°26'26.06"W</td></tr> <tr> <th data-bbox="191 552 267 594">Notes</th><th data-bbox="267 552 810 594"></th></tr> <tr> <td data-bbox="191 594 267 772"></td><td data-bbox="267 594 810 772">Fine organic sediment in pond upstream of culvert. Source of material is from natural sources</td></tr> </table>	21	Location		Creek 6 – pooling on upstream side of road, perched culvert	GPS			49° 6'47.20"N 117°26'26.06"W	Notes			Fine organic sediment in pond upstream of culvert. Source of material is from natural sources

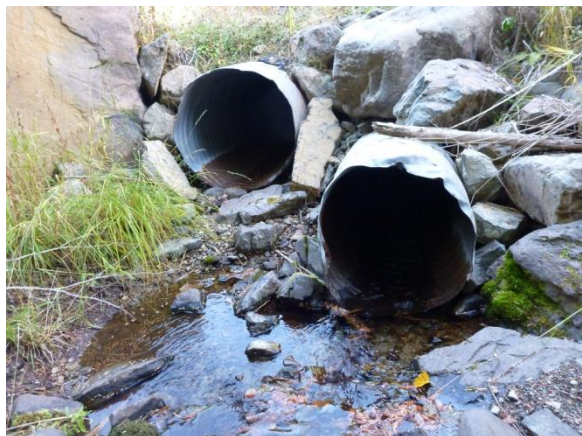
23	Location

Creek 7 culverts												
GPS													
	49° 6'25.59"N 117°27'39.55"W												
Notes													
	Stable channel

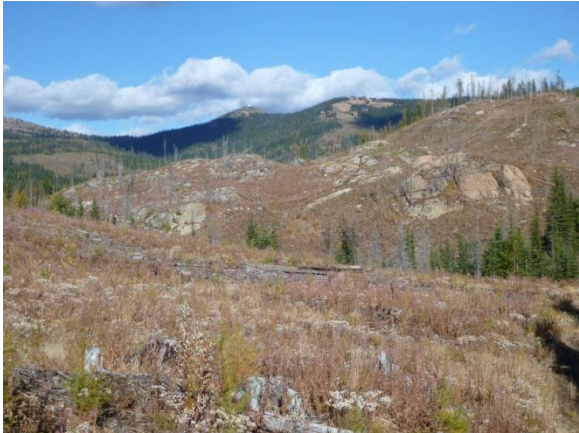
<b>24</b>	<b>Location</b>	
	High elevation south cut block	
	<b>GPS</b>	
	49° 6'12.55"N 117°27'46.63"W	
	<b>Notes</b>

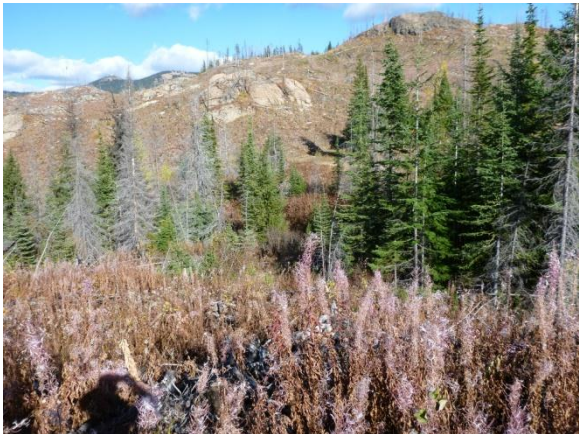
<b>25</b>	<b>Location</b>	
	Creek 8 – showing riparian area	
	<b>GPS</b>	
	49° 6'12.55"N 117°27'46.63"W	
	<b>Notes</b>	
	2007 wildfire did not burn the riparian area along the creek

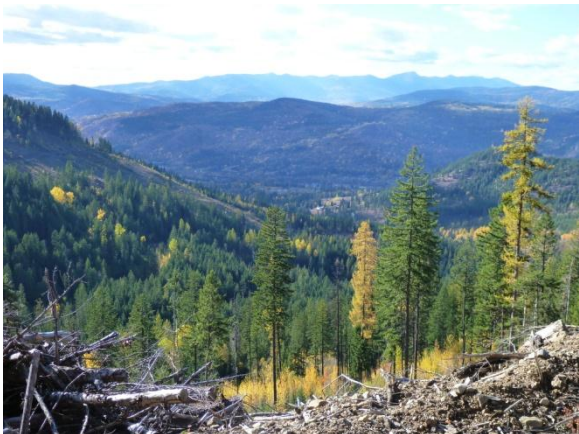
<b>26</b>	<b>Location</b>	
	Westward view of the watershed towards Fruitvale	
	<b>GPS</b>	
	49° 6'12.55"N 117°27'46.63"W	
	<b>Notes</b>

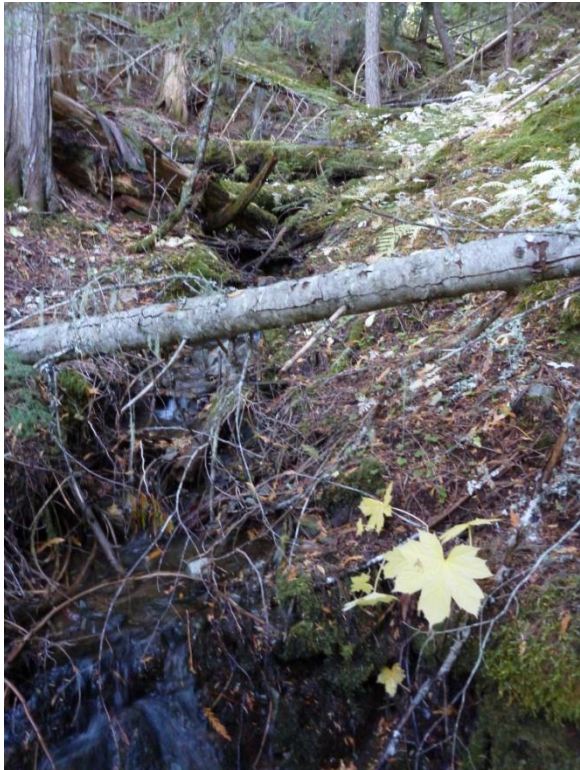
<b>27</b>	<b>Location</b>	
	Creek 9 upper reach	
	<b>GPS</b>	
	49° 6'13.20"N 117°28'47.29"W	
	<b>Notes</b>	
	Small, stable, headwater channel

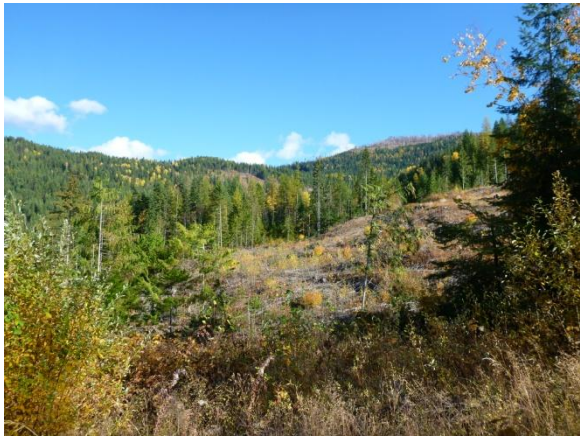
<b>28</b>	<b>Location</b>	
	Northward view of the watershed	
	<b>GPS</b>	
	49° 6'12.51"N 117°29'6.48"W	
	<b>Notes</b>

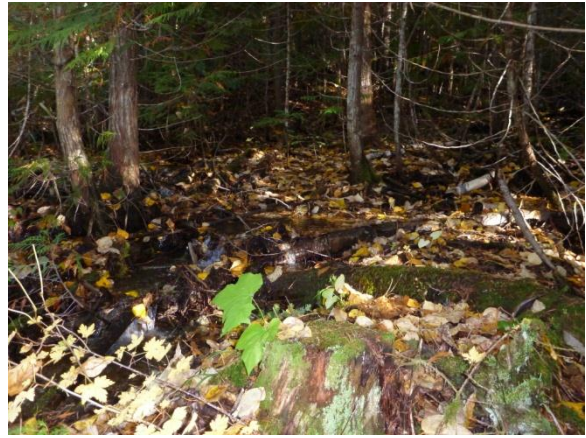
<b>29</b>	<b>Location</b>	
	Creek 9 – lower reach fan	
	<b>GPS</b>	
	49° 6'30.14"N 117°29'35.26"W	
	<b>Notes</b>

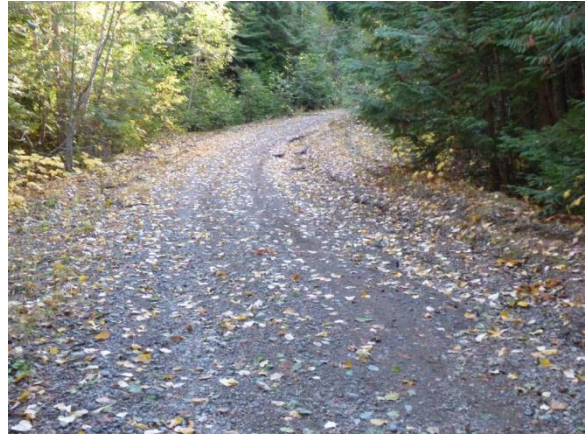
<b>30</b>	<b>Location</b>	
	Road erosion	
	<b>GPS</b>	
	49° 6'29.93"N 117°29'38.45"W	
	<b>Notes</b>
